Failure Investigation Report

Well Failure at Todd Energy Canada Ltd.

January 2019

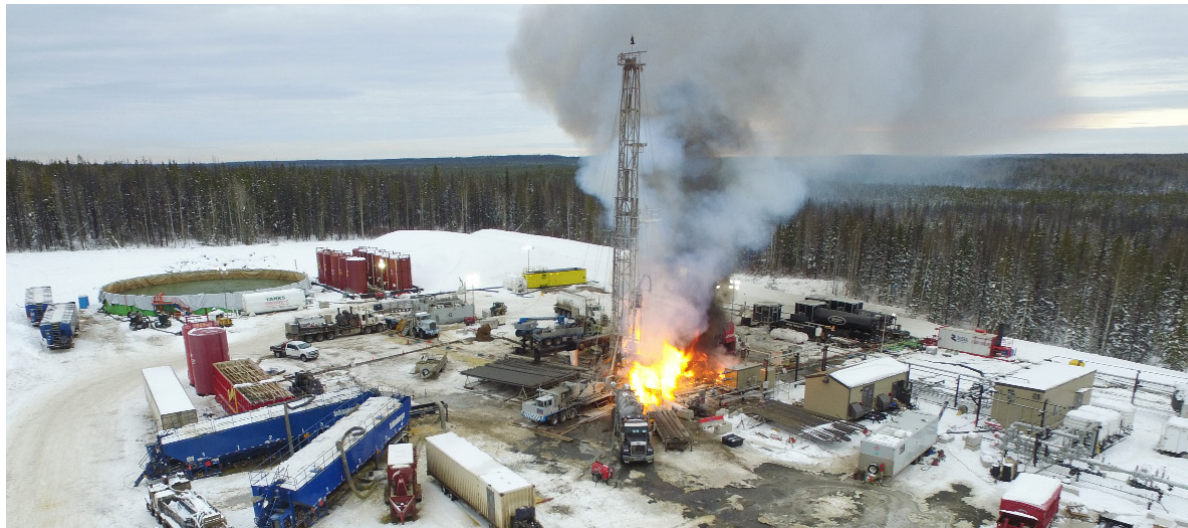
On December 4, the fire from the 'O' well caused the service rig on the 'A' well and a crane on site to topple. The service rig derrick landed on the 'O' well. The impact of the derrick bent the wellhead of the 'O' well. Figure 3 on the following page shows the layout of the wells and the impact of the fire on the 'A' well. The damage to the 'O' wellhead eliminated any ability to shut the well in, complicating and extending the operations required to bring the well under control.

Figure 2: Photo of the incident location prior to collapse of the service rig.

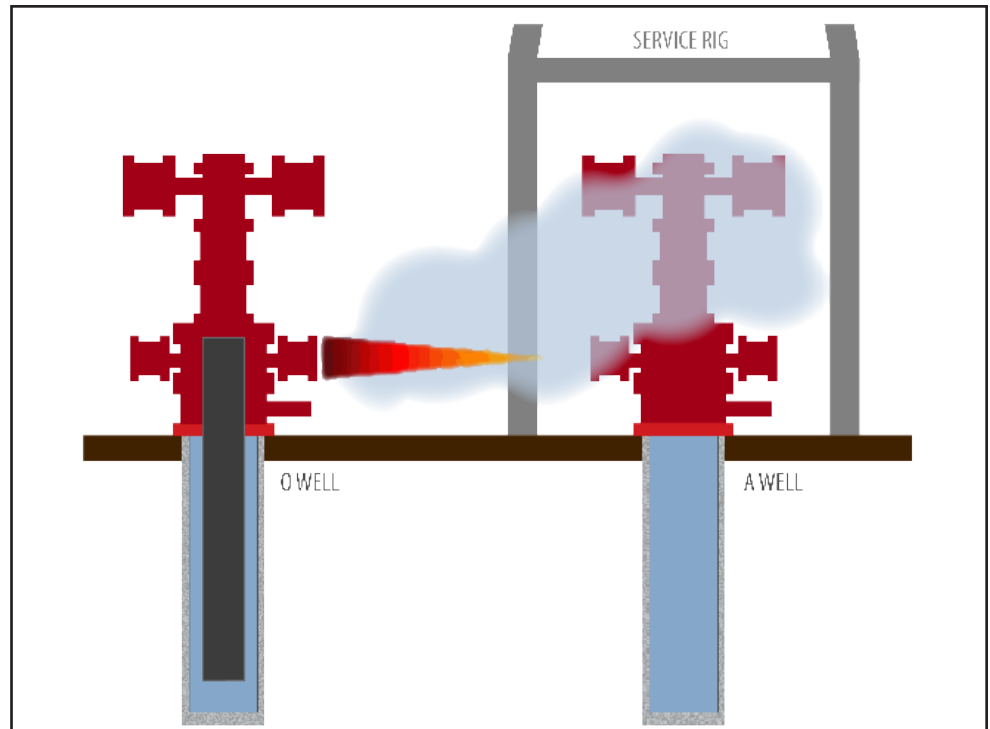
On December 13, operations began to remove the damaged wellhead from the 'O' well. Two cuts were made and the damaged wellhead was removed by December 15. Once the damaged wellhead was removed, the flow from the 'O' well was in the vertical direction instead of horizontally towards the 'A' well. At this point it was confirmed that the seals on the 'A' well were leaking and the 'A' well was confirmed to be flowing and on fire.

Figure 3: Illustration of the failure event.

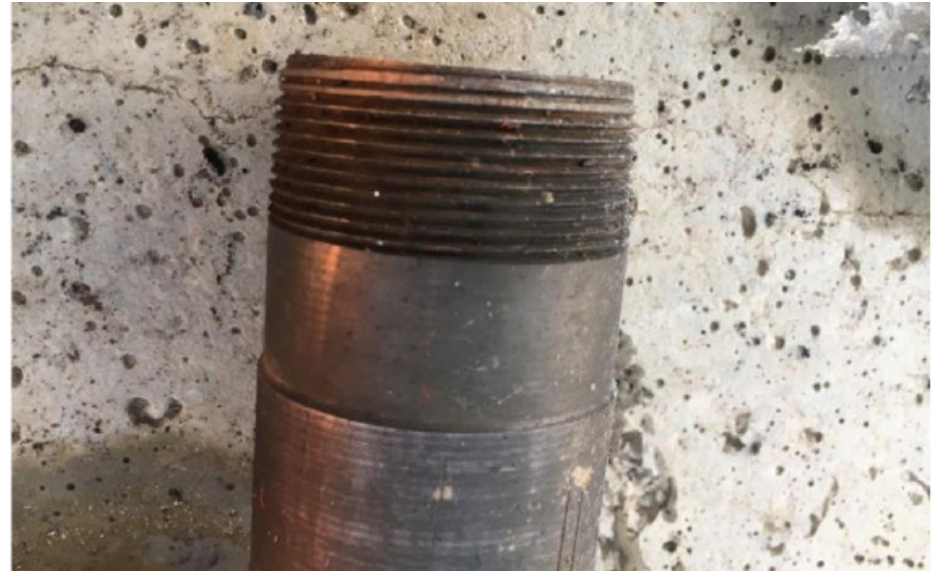
Collection of physical evidence was compromised due to the fire, duration of the incident and scope of operations required to regain well control. Physical evidence recovered from the site included the wellhead from the 'O' well, a two inch bull plug that was found at the base of the wellhead (Figure 4) and the backplate of the pressure gauge that was installed on the well. The backplate of the pressure gauge was recovered shortly after the incident by TECL and was subsequently misplaced during the emergency response effort.

Figure 4: Bull plug recovered from base of the 'O' well showing damage on first two threads.

- The first two rounds of the external thread on the bull plug were plastically deformed by axial shear. No plastic deformation associated with shear damage was observed beyond the first two thread rounds.

- The bull plug did not contain any mechanical marks on its external surface consistent with the application of axial force capable of shearing its threads. This was consistent with the internal pressure force being applied.

- The bull plug contained tool marks consistent with its assembly, but did not contain any tool marks consistent with its disassembly.
- Based on plastic deformation, the bull plug was engaged by two turns at the time of failure.

- The deformation damage of the bull plug was a mirror image of the deformation damage of the NCF.
- Virtual fit-up showed that without plastic deformation, the NCF and bull plug could be engaged by 4.5 turns.

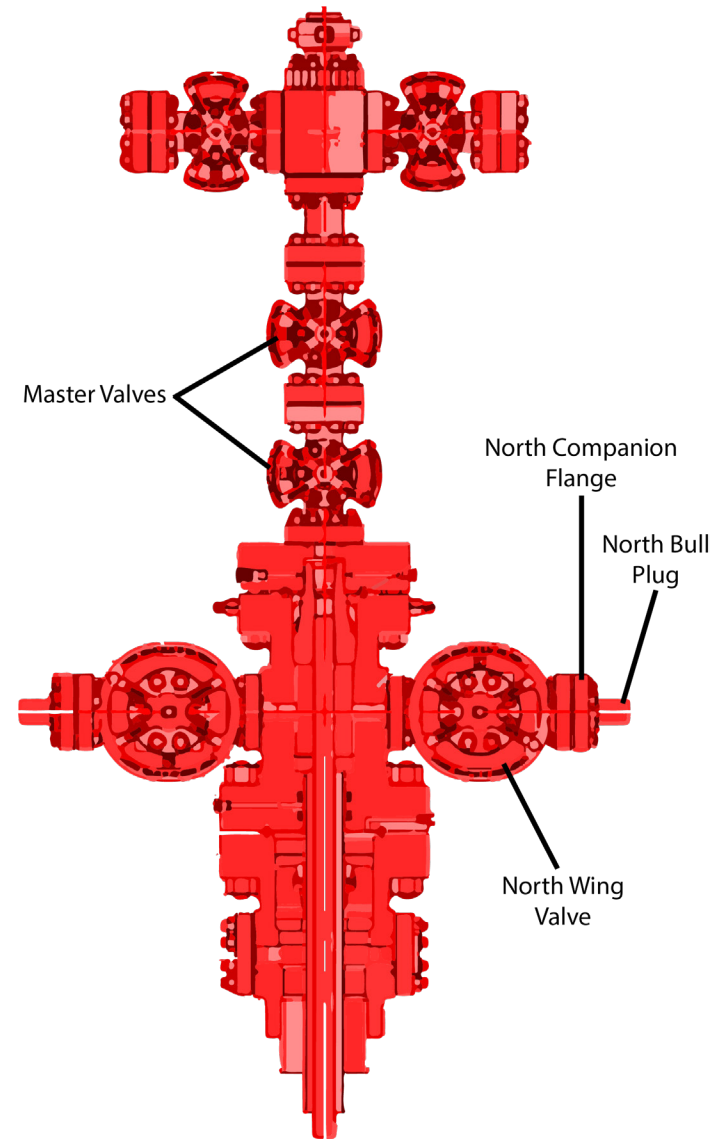
The gas release was initiated from the north side wing valve of the 'O' well. A two inch threaded bull plug and pressure gauge were installed for the purposes of monitoring the casing pressure.

- The wellhead contained all of the parts specified by the wellhead supplier, StreamFlo Industries Ltd., except for the North Bull Plug.
- Except for the thread damage to the North Companion Flange (NCF), there was no pre-existing mechanical damage of the wellhead that could have contributed to the North Bull Plug separation.

- Mechanical damage to the first three thread rounds of the NCF and the first two thread rounds of the bull plug showed they were likely engaged at the time of failure and the failure was consistent with internal pressure.

- The first three thread rounds of the NCF were plastically deformed by connection with a bull plug prior to the failure event. This deformation would have prevented engaging with another bull plug. No plastic deformation associated with shear damage was observed past the first three thread rounds. The plastic deformation was consistent with shearing the thread due to internal pressure.

Figure 5: Diagram showing the cross section of failure location.

- The damage to the casing flange and bull plug threads were a mirror image, indicating that they had been engaged. The damage to the threads of the casing flange would have prevented engaging another bull plug past the damaged area.
- The casing flange and the bull plug had been engaged by two threads.

- The threads of the casing flange and bull plug could have been engaged by 4.5 turns.
- The bull plug was not fully engaged in the casing flange.
- The failure of the threads on both the bull plug and the casing flange was consistent with failure due to internal pressure.
- Based on the available evidence, the bull plug found at the well was likely installed in the north casing flange at the time of the failure.
- Had the north casing flange and the bull plug been fully engaged, the pressure of 18.6 MPa would have been insufficient to cause a shear failure of the threads.

Based on the preceding observations and statements, the Commission has determined the probable cause of the incident was human error when installing the bull plug on the north casing flange of the wellhead. Had the threads of the bull plug been fully engaged in the north casing flange, it is unlikely that well control would have been lost.

1. Todd Energy Canada Ltd. shall develop a procedure to ensure that wellhead components are assembled by competent personnel and that connections are inspected and documented prior to being pressurized.

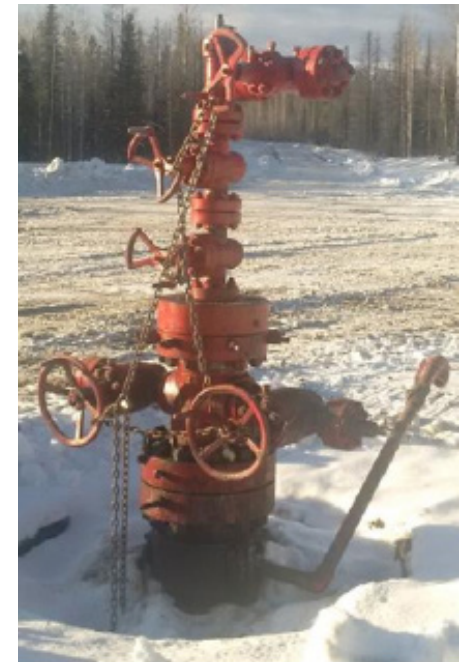
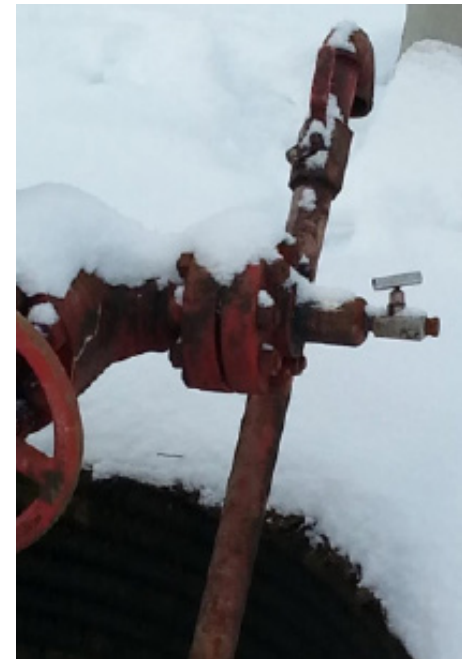
- A picture of the wellhead of the 'O' well, taken during a suspended well inspection in February 2016 shows that a red painted bull plug was installed in the north casing flange of the wellhead.

Figure 6: Photos of the 'O' well taken by TECL February 2016.
