Failure Investigation Report

Well Failure at Todd Energy Canada Ltd.

January 2019

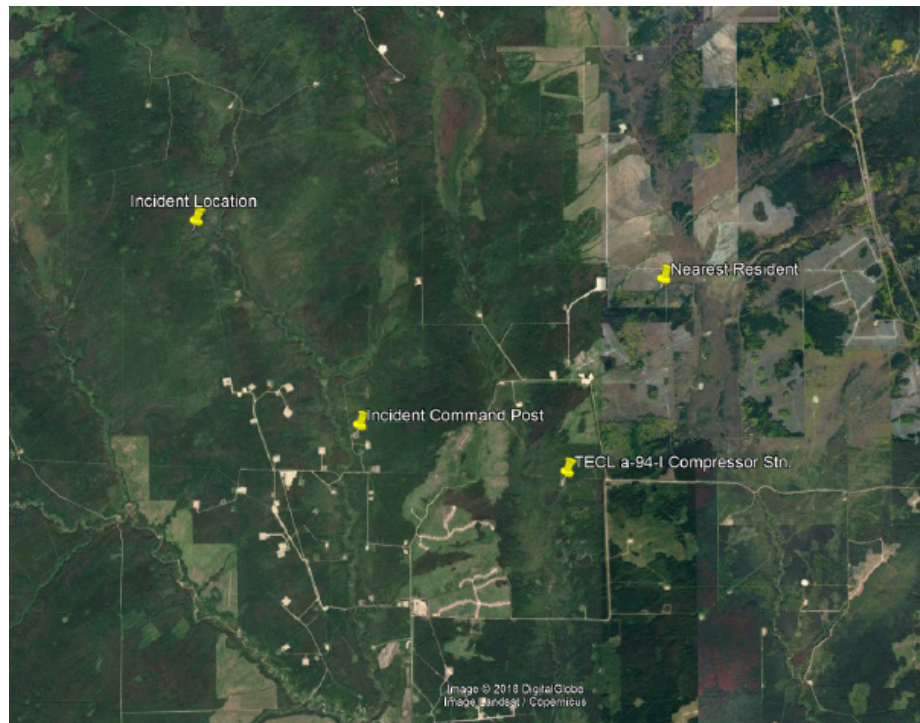
Figure 7: Air Monitoring Locations

Monitoring was located at the incident location, the site of the nearest resident, the incident command post and the Todd Energy a-44-I compressor station (Figure 7 - previous page). On Dec. 15 at 2:30 a.m., air quality monitors detected elevated readings of 12 ppb H₂S and 13 ppb SO₂ at the location of the nearest resident, approximately 8.4 km to the northeast of the incident location. Readings returned to normal by 3:45 a.m. Offsite H₂S exceeded the B.C. air quality objective of 5 ppb, but did not pose a health risk. SO₂ was below the one hour national air quality standard of 172 ppb.

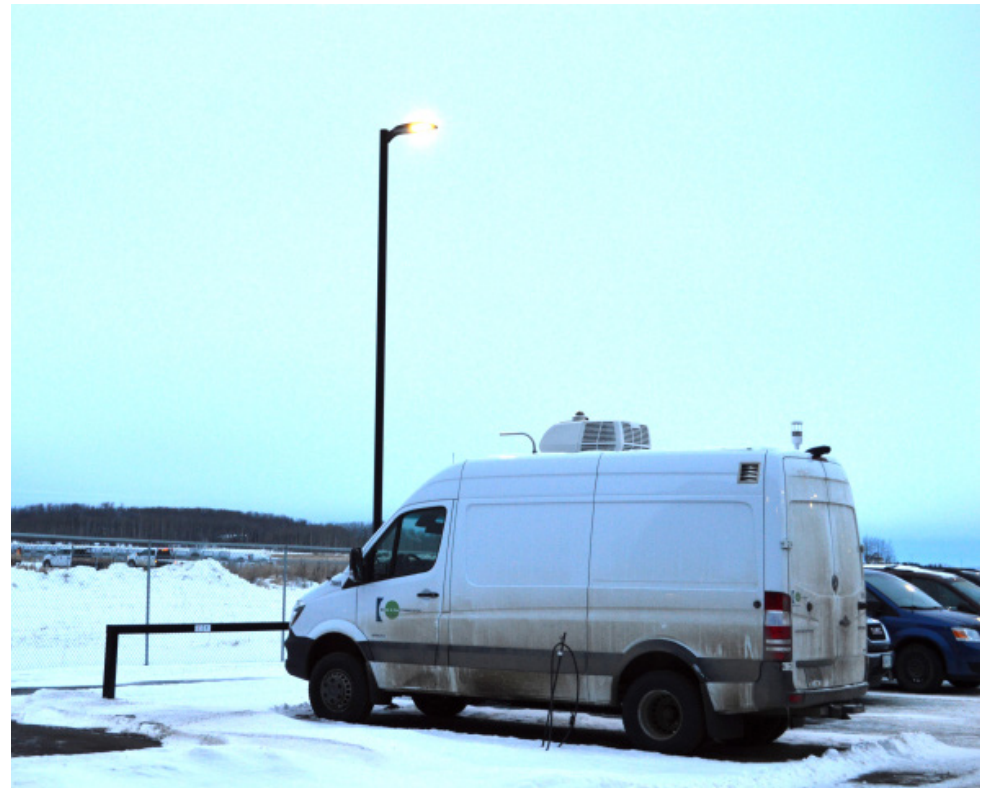
Figure 8: Photo of the Commission Roaming Air Monitor Unit.

Throughout the incident response, air was monitored on site through the use of personal gas monitors. In addition, TECL and the Commission deployed mobile air monitoring units to monitor air quality in the vicinity of the site (Figure 8).
